# Final Report

## MECHANICAL REMOVAL OF BIOFOULING

FRDC Project Number 92/153

Salmon Enterprises of Tasmania Pty. Ltd. (Saltas)

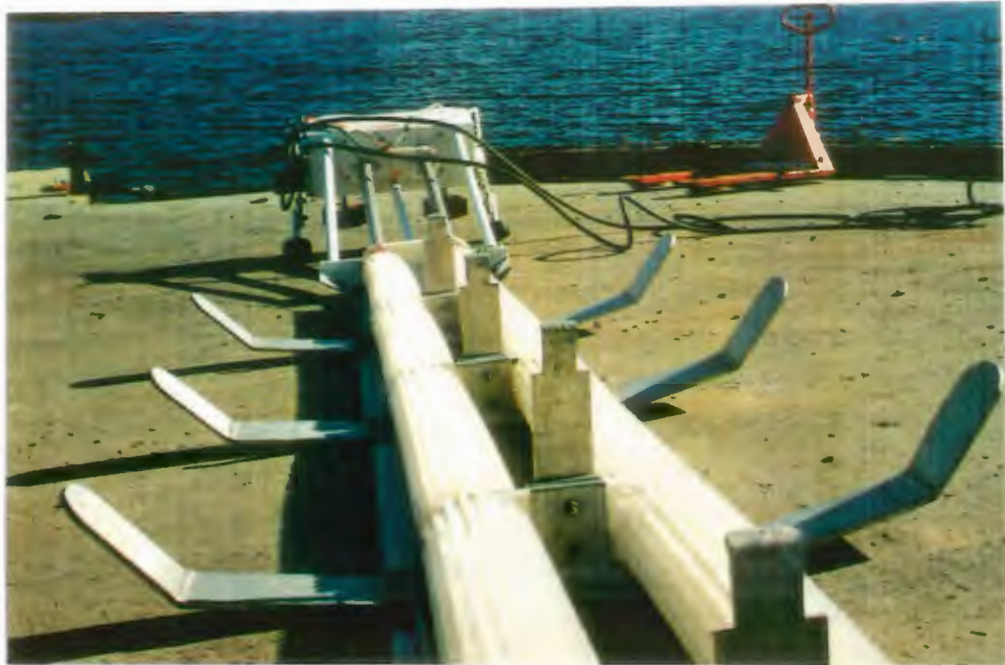
**Figure 3.** Prototype net cleaner showing lateral, aluminium side arms, designed to help stop twisting of brush lines

Unequal torque reactions resulted in the brush-lines twisting around each other. This resulted in one line of brushes being lifted away from the net and the other buckling away from the net. Aluminium side arms (600 x 150 x 12 mm) (Figure 3) designed to counter the twisting moment, were attached to both sides of each connecting bush.

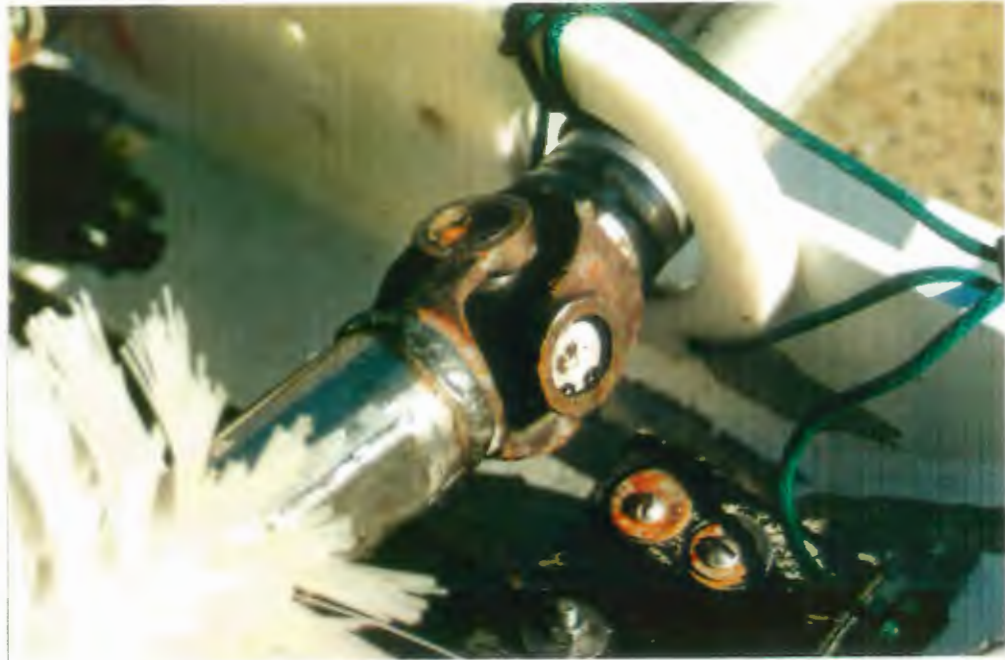
**Figure 7.** Close-up of join between drive shaft and the top brush of one brush line showing the universal joint used to replace the uppermost plastic bushes

Unless particular care was taken when preparing the net for cleaning, the final angle between the drive shafts and top brushes was too great to be accommodated by the uppermost plastic bushes. Each of these bushes was replaced by a steel universal joint (Figure 7), one end of which was welded to a drive shaft, while the other was securely connected to the top brush in each brush line. In some cases (eg. when operating the prototype net cleaner on a smaller pen), it was impossible to arrange the net to provide a suitable contact angle for the net cleaner. An aluminium spacer, attached to the bottom of the main drive unit (Figure 8), decreased the contact angle sufficiently to allow the cleaner to operate normally.

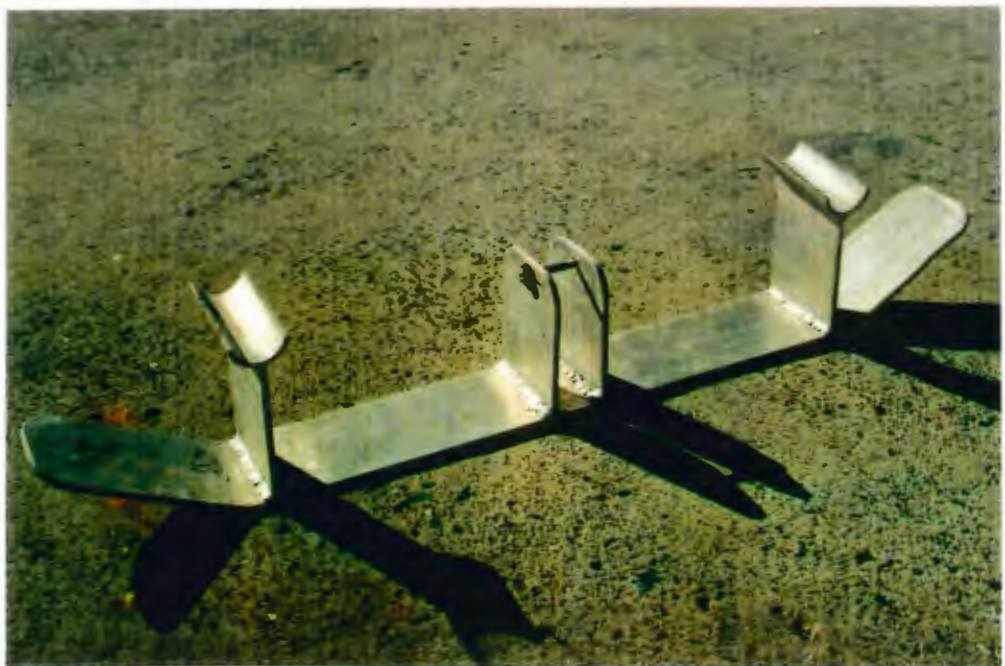
**Figure 8.** Aluminium spacer designed to reduce the contact angle between the top brushes and nets on some pens

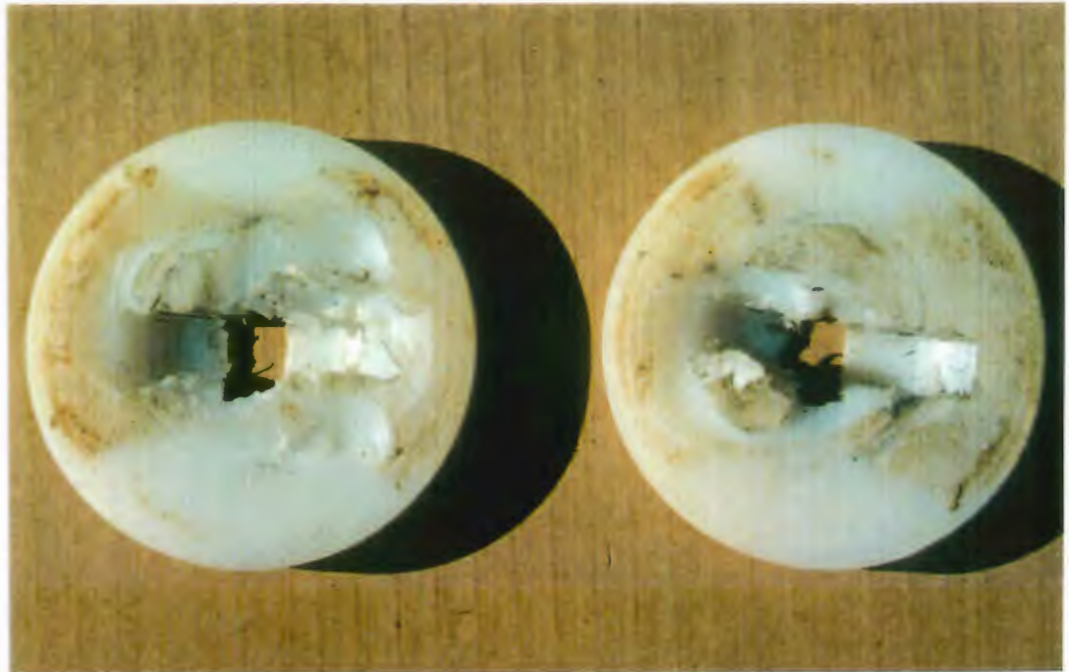
**Figure 9.** Close-up of plastic bushes damaged by the stainless steel end pieces of the drive shafts

After several hours service, it was found that the plastic bushes between the second and third brushes were becoming badly damaged by the stainless-steel brush end-pieces (Figure 9), resulting in breakage of the central cables. Replacement of these damaged plastic bushes with stainless-steel bushes remedied this problem.

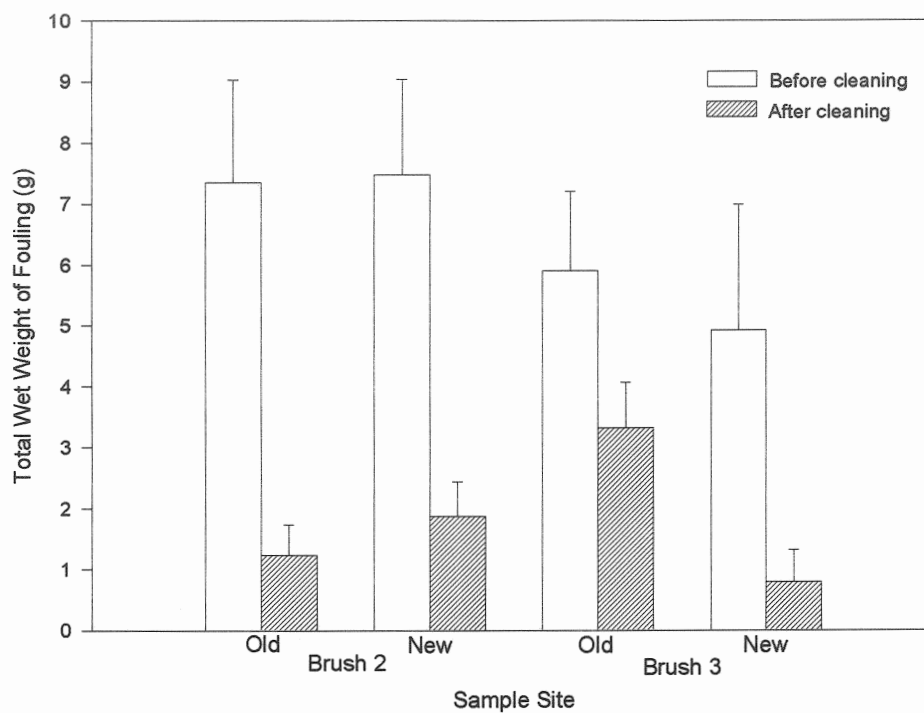
**Figure 10.** Wet weight (gm) of fouling before and after cleaning using modified brush configuration

Further modification of the cleaner, achieved by removing ~5 mm from the bottom (closest to the net) side of the plastic connecting bushes, provided greater contact between the brushes and net. Operation of the prototype net cleaner under this new configuration resulted in a significant increase in cleaning efficiency. A trial, incorporating a destructive sampling strategy, demonstrated that a significantly greater amount of fouling (wet weight) was removed from an established community, with the fouling reduced from  $5.9 \pm 1.3$  g/100 cm<sup>2</sup> to  $3.3 \pm 0.7$  g/100 cm<sup>2</sup> and from  $4.9 \pm 2.1$  g/100 cm<sup>2</sup> to  $0.8 \pm 0.5$  g/100 cm<sup>2</sup> using the original and modified configurations respectively (Figure 10).

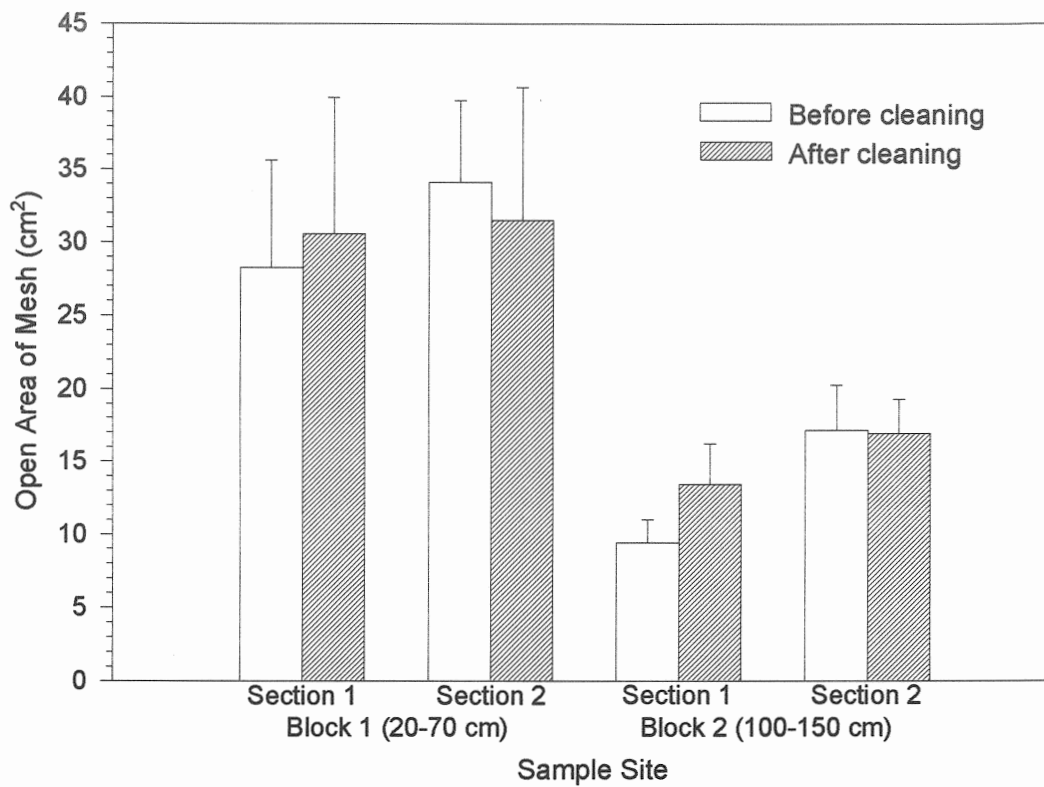
Figure 5.

Analysis of the fouling-removal trial (Fig. 5) found no significant difference in mean blockage before and after cleaning ( $P=0.75$ , ANOVA). The cleaner used in this trial (a different machine from that of trial 1) did remove some fouling from the net during operation. However, contact between the cleaning brushes and the netting was insufficient to remove material close to the net. Consequently, the cleaner cropped the upper fraction of the fouling community, but left the lower structures unaltered, resulting in no reduction in net blockage.

**Fig. 5** The mean area (n=12) of open mesh in each sample block, before and after cleaning. Bars = 95% confidence levels.

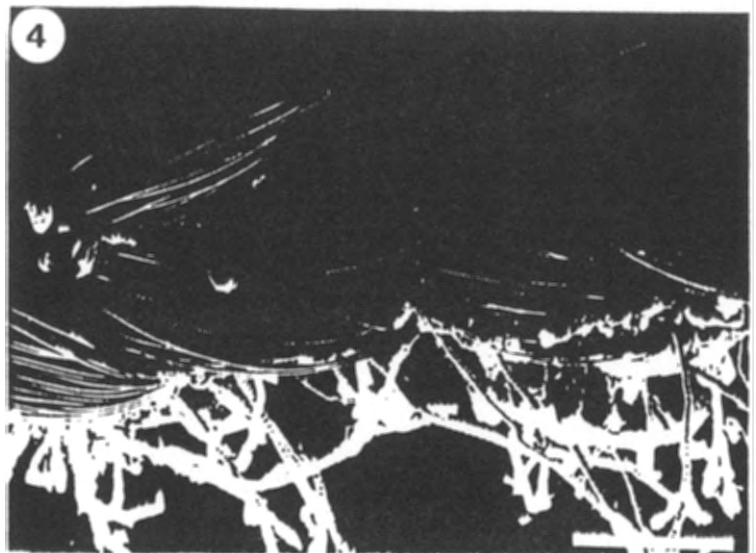
Figures 3-5. Hydroid communities remaining on netting after cleaning. The inner and upper surfaces are very clean, however the lower surfaces show many hydroids.

Both the hydroid removal and the fouling regeneration trial demonstrated that the brush tester effectively cleaned the majority of fouling off the netting. However, remnants of hydroids were clearly visible on the outer surface of the cage, and the bulk of these were only slightly damaged. The regenerative capacity of hydroids is well recognised (Buchsbaum *et al.*, 1987). The colonies which remained on the outer and lower sides of bars should recover quickly, however, the recovery of the small remaining basal areas on the cleaned surfaces (Figs. 8, 9, 10) may be limited.

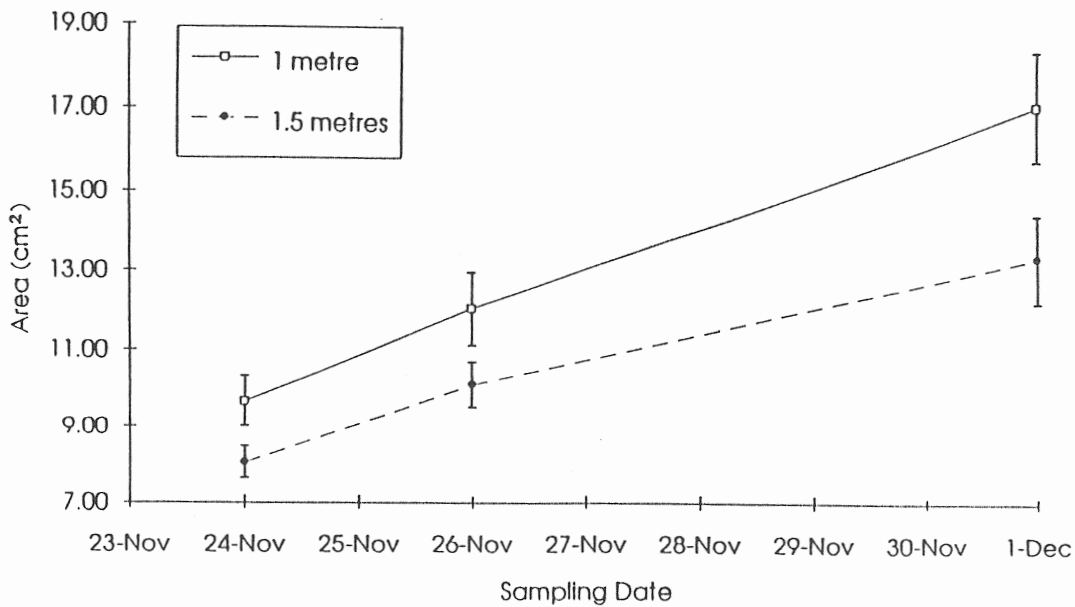
Figure 7. Increase in area fouled during the 7 days following cleaning. Each point represents the mean of 9 samples. Bars = 95% confidence levels.

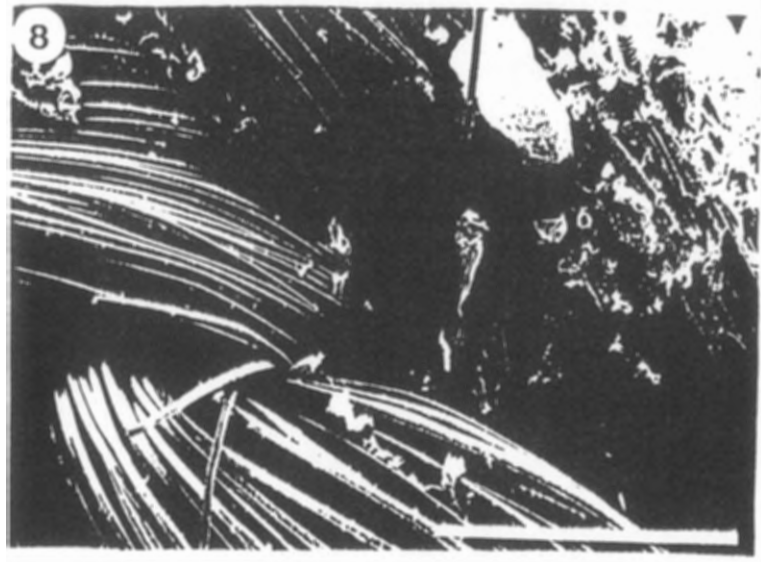
Figures 8-9. Absence of microalgal fouling after cleaning. The hydroid remnants which remain have been severed close to the surface.
